**CONDOR EARTH TECHNOLOGIES, INC.**

October 9, 2014

**Subject:** Summary and Recommendations – El Portal Fire Sediment/Debris Runoff Mitigation,  
Title I Services Scoping Trip, Old El Portal, California, Yosemite National Park  
Condor Project No. 6945

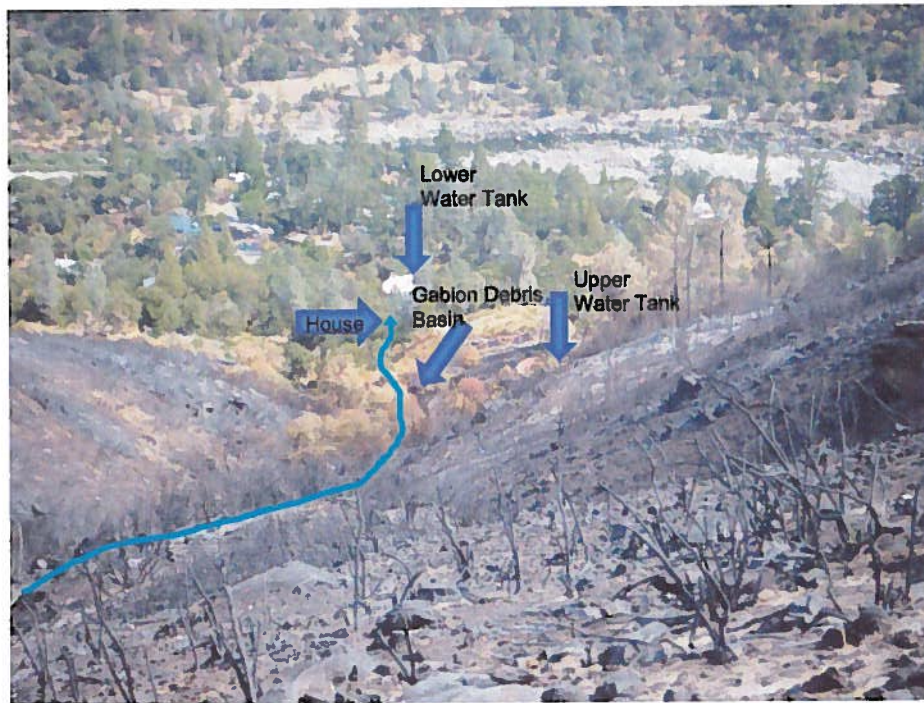
**House in drainage near water tank-** There is a house located directly within the mouth of a 33 acre ephemeral drainage (Figures 1 and 2). The drainage is narrow, steep (average slope-63%), and very rocky with rock outcrops at its head. The entire watershed was burned, with soil burn severity dominated by *Moderate* (Table 2). This house previously experienced flooding and fine sediment deposition during a storm event in March 1991 that occurred after the watershed was burned during the August 1990 Arch Rock Fire (DeGraff 1991). A rock gabion dam debris basin with an approximately 200 cubic yard capacity was constructed in the channel upstream from the house near the upper water tank after the Arch Rock Fire to provide protection from debris flows; the March 1991 event filled the structure about half full with fine sediment and ash (DeGraff 1991).

Figure 2: Looking down into water tank drainage from Foresta Road

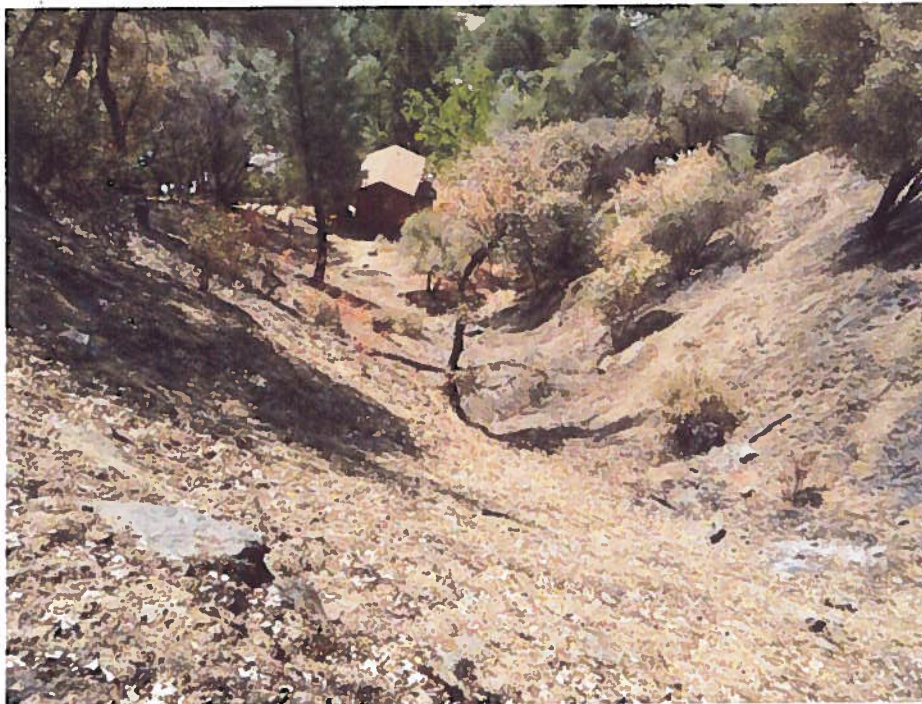
**House in drainage on Buckeye Road-** This house is located directly within the mouth of an 18 acre ephemeral drainage and was identified during field reconnaissance (Figures 1 and 3). This drainage is also narrow, steep (average slope- 55%), and rocky with rock outcrops at its head. Nearly all the watershed (91%) was burned, mostly at a *Moderate* soil burn severity (Table 2). The drainage becomes indistinct at the house and it appears no other homes are at risk. The house experienced a small debris flow during the March 1991 storm event which deposited 1 foot of debris against the back of the house (DeGraff 1991). Several unsuccessful attempts were made to contact the homeowner. Where Foresta Road crosses the drainage upstream from the house, there is potential for runoff to divert onto the road and flow down to water tank.

Figure 3: Looking down into Buckeye Road drainage from Foresta Road

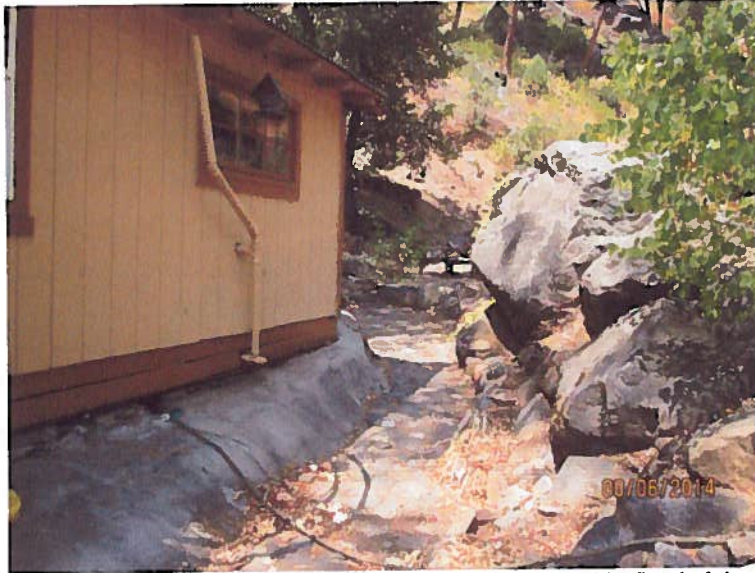
**Photo 1 - House #1 at 5674 Forest Road. House is located in flood plain of channel and has constricted the cross-sectional area of the channel. This house has slopes above with moderate debris flow hazard and the potential for 1000-10,000 yds<sup>3</sup> of debris flow material to pass through this narrow channel. There is a very high risk to life and property at this site.**

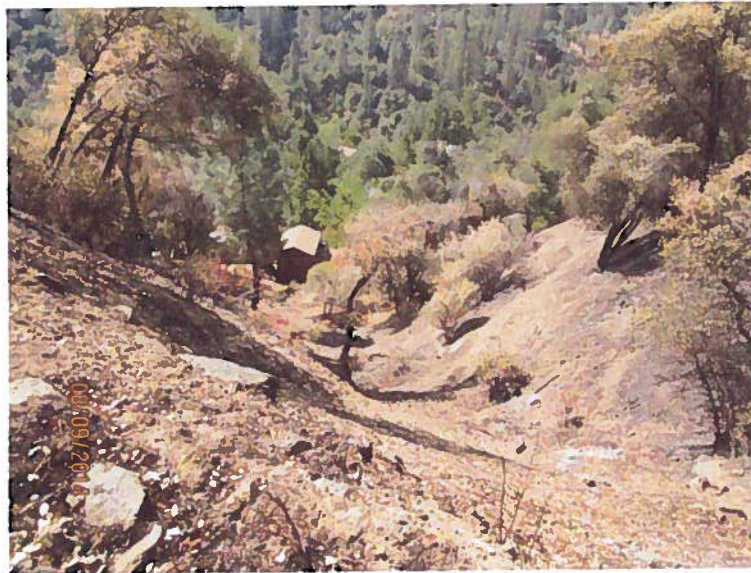
**Photo 2 - House #2 at 9722 Buckeye Road. House is located below channel with slopes that have a with moderate debris flow hazard and the potential for 1000-10,000 yds<sup>3</sup> of debris flow material to pass through this narrow channel. There is a very high risk to life and property at this site.**

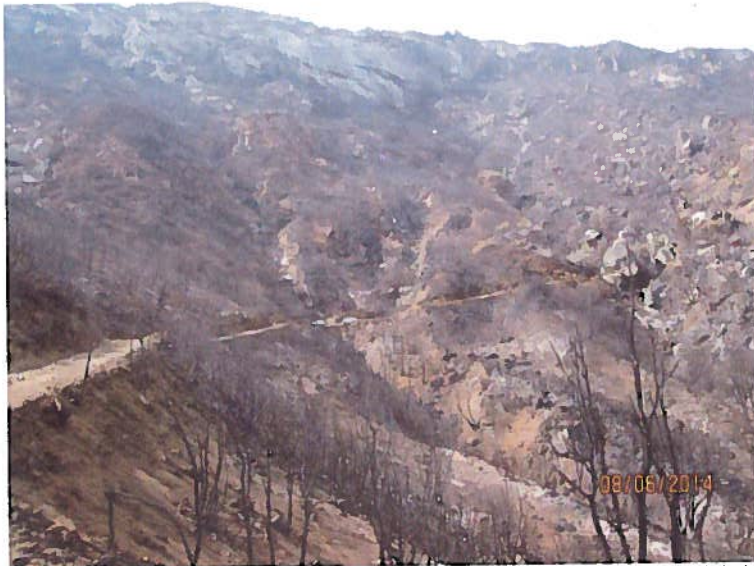
**Photo 3 - Foresta Road (FR2S84)** This road has high and moderate debris flow and rock fall hazard. People driving this road could get trapped behind rock fall and are at risk from getting hit by a rock.

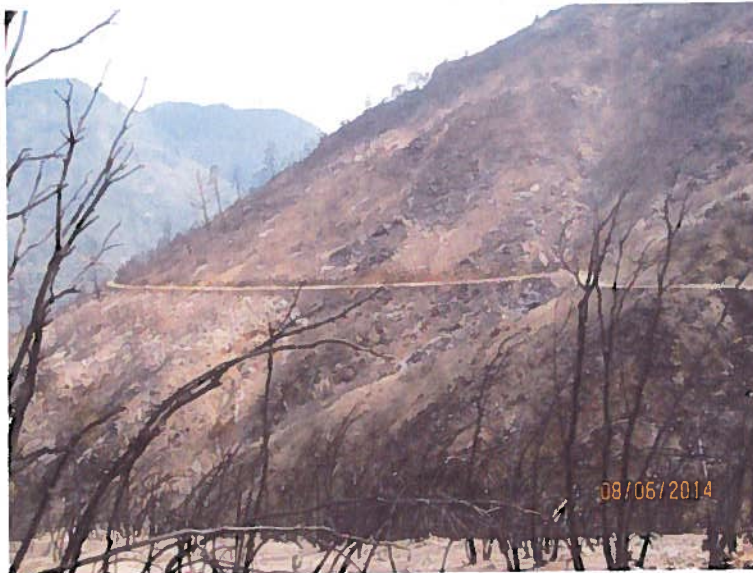
**Photo 4 - Foresta Road (FR2S84)** This section of road has a moderate rock fall hazard. People driving this road could get trapped behind rock fall and are at risk from getting hit by a rock.

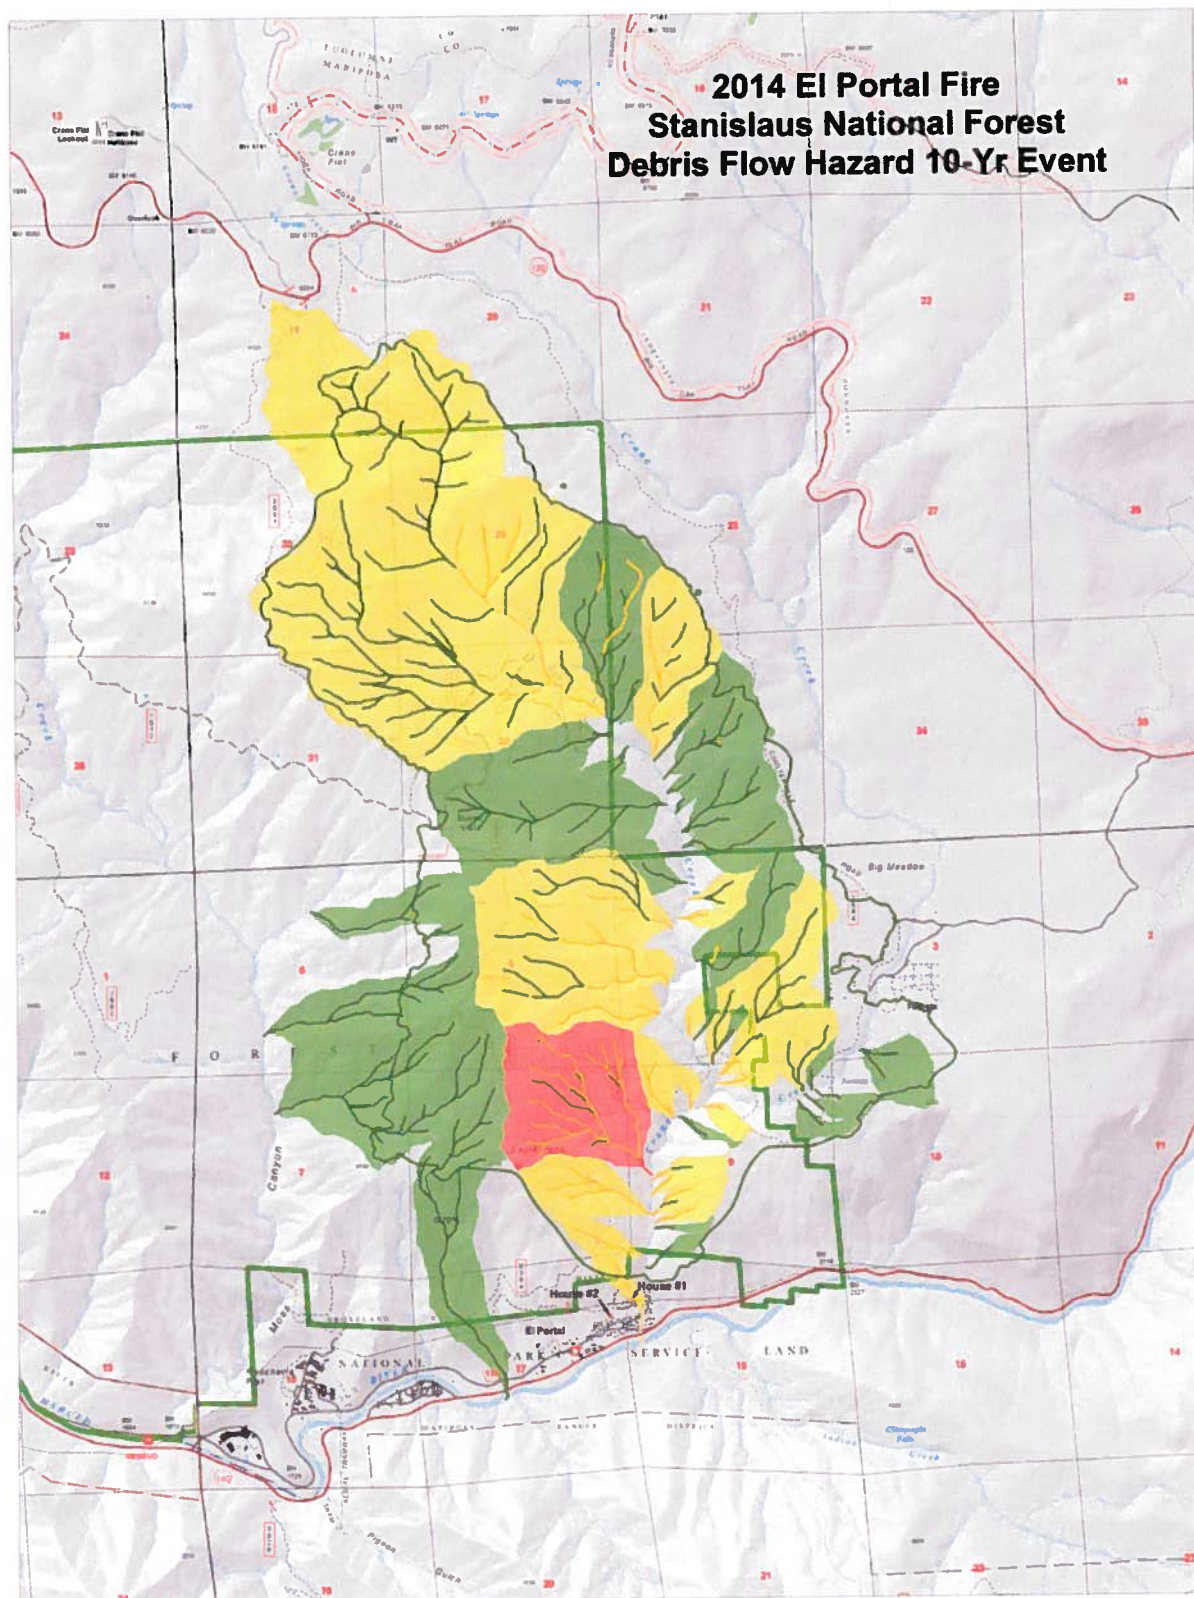
of debris flows occurring for multiple precipitation events including the 2 year, 5 year, 10 year, 25 year and 50 year storm events. The 10 year event was used to evaluate debris flow potential for the fire area (see Figure 2). The two houses are located downstream from Moderate Debris Flow Hazard Areas with a 20-40% probability of 1000 – 10,000 yds<sup>3</sup> debris flows to move down the channel. One of those houses is constructed within the flood plain of the channel with very little cross-sectional area for water to pass much less a debris flow. It is highly likely that if a debris flow flows down this channel that it will destroy the corner of the house and could potentially take the life of someone occupying the room near the channel.

Figure 2 – Debris Flow Hazard Map showing houses #1 and #2 downslope of moderate debris flow hazard areas. Note red shaded area, where Foresta Road is located. This area is a high debris flow hazard area.

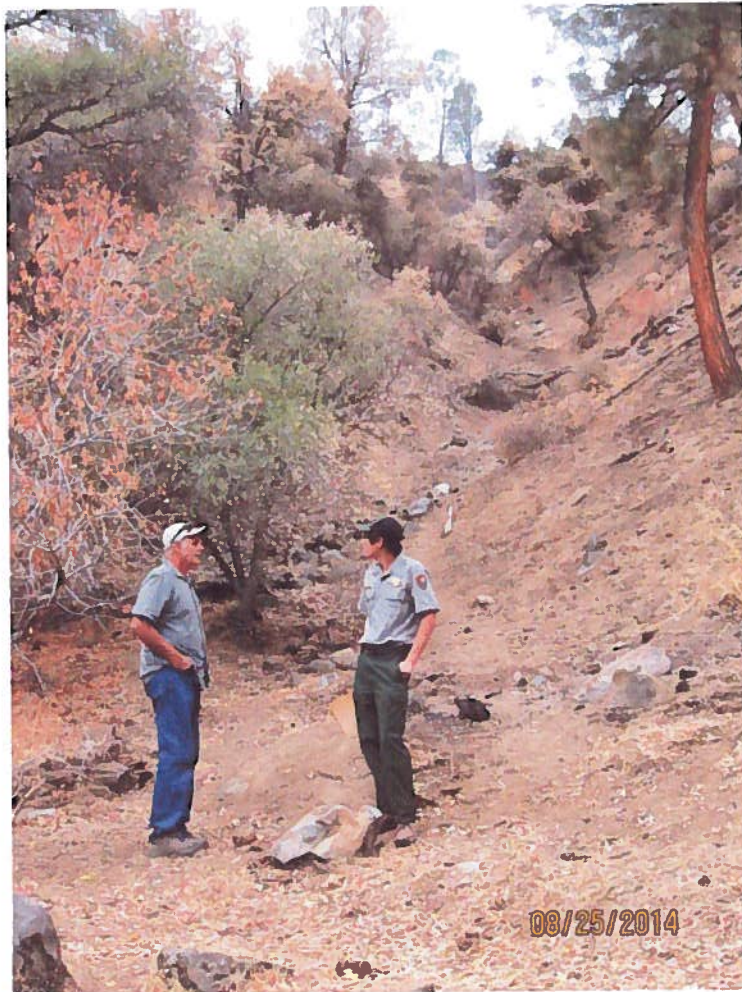
**Buckeye Photo: 2193 – Area of potential gabion debris dam.**

In our opinion, we would suggest an approach similar to that used at the Foresta Road house, whereby a combined gabion or other structure capable of retaining a minimum of 89 CY (post fire, 2-year event), combined with a deflection device immediately adjacent to the house. The retention structure should be located some distance away from the house (See drainage area in Photo 2193, attached) and deflection device close to the house (see area in vicinity of Photo 2195 and 2196, attached). Both structures should be capable of managing a flow of 3 cfs (post fire 2-year event) for peak flow.

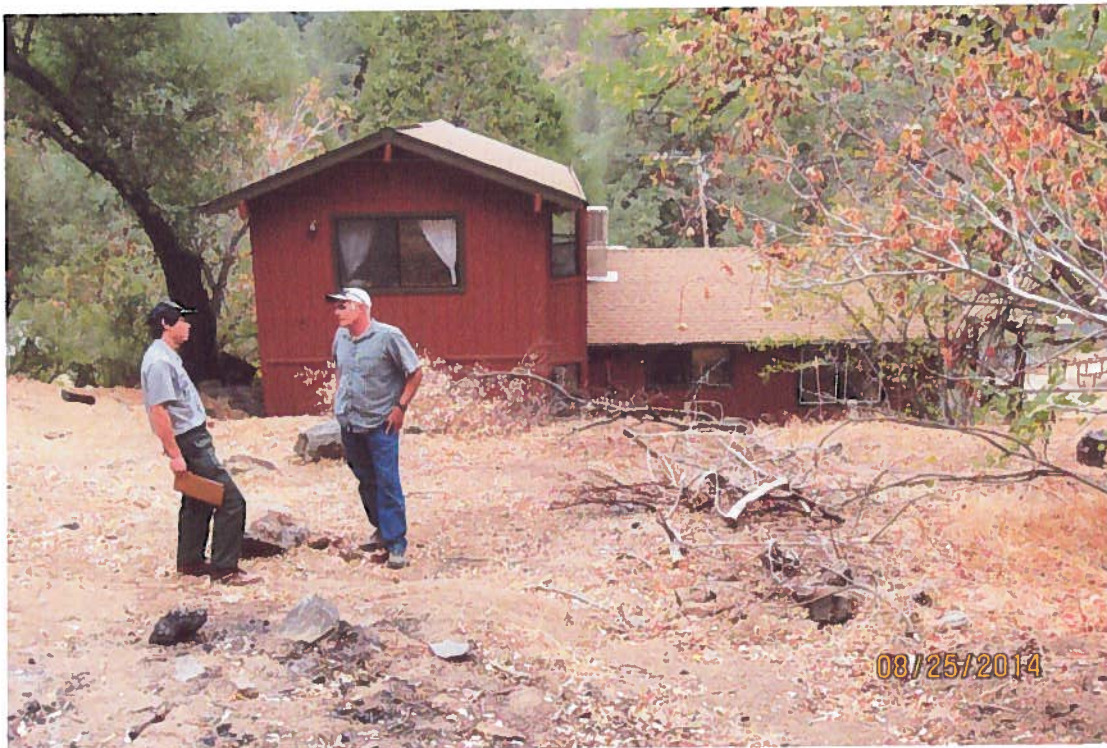
**Buckeye Photo: 2195 – Area of debris deflection barrier.**

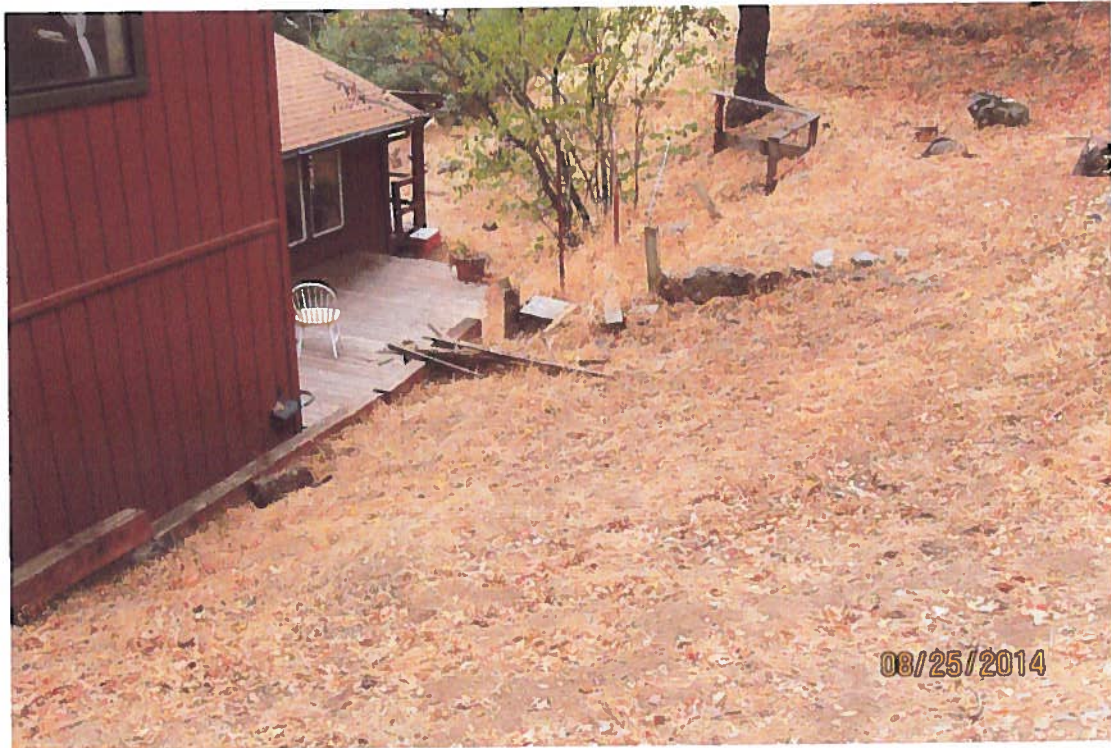
**Buckeye Photo: 2196 – Area of deflection debris**

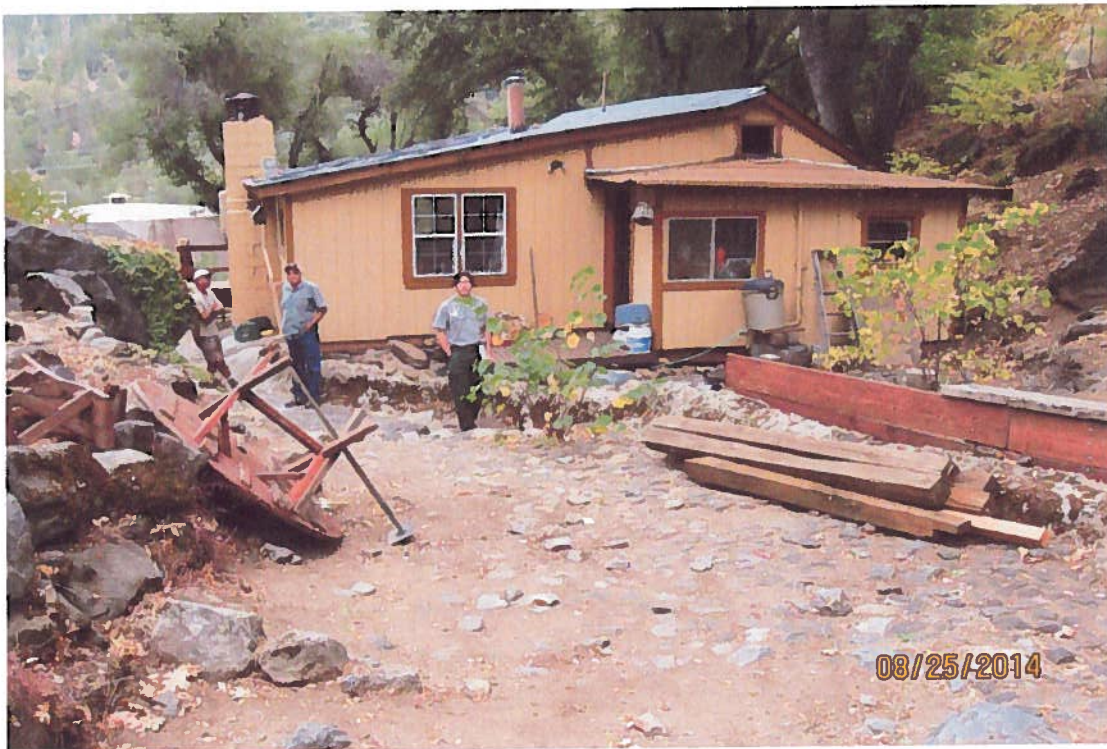
**Foresta Road Photo 2208 – Owner constructed deflection barrier in progress**

We agree with bullet two (deflection barrier), but recommend a more permanent barrier of the style that owner has started construction on (Photo 2208, attached). The deflection device should be capable of deflecting the post fire flow of 6 cfs, which would allow for the filling of the debris gabion and the subsequent over-top during a 2-year precipitation event or multiple 2-year events in close succession (within a year or multiple years). The height of the deflection barrier could potentially impact the view of the resident due to the close proximity of their window, and the constricting nature of the flow path directly adjacent to the building. If the 6 cfs cannot be reasonably accommodated, the height could be lowered, but should accommodate no less than 2 cfs (the pre-fire peak flow for 2-year event). We would

estimate the cost of engineered design-build improvements to meet the stated criteria to likely range from \$20,000 to \$50,000 for this item.

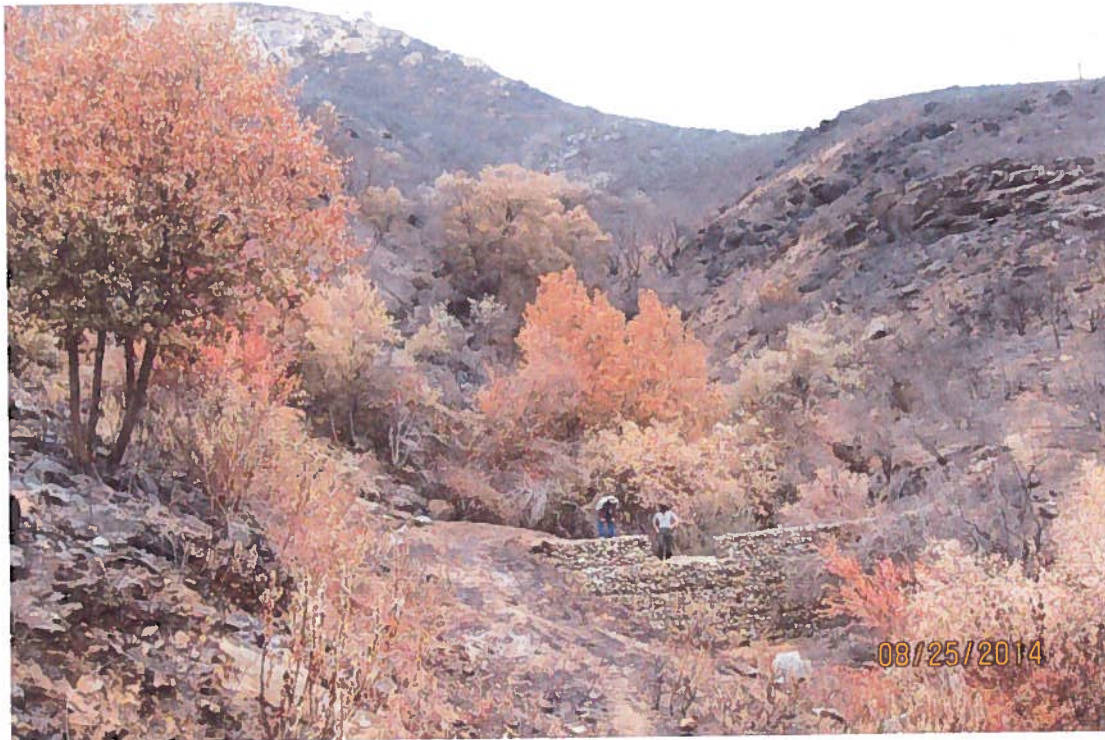
**Foresta Road Photo 2211 – Existing Debris Dam, looking at downstream side.**

We agree with bullet one (gabion clean-out) since the gabion was designed to retain a volume of 200 cubic yards (CY), and the post fire predicted volume is 203 CY (See Photos 2211 and 2215). We would estimate the cost to perform the removal, monitoring, and subsequent removal over the next 2 to 4 years to range between \$10,000 to \$50,000, depending on whether additional repairs/stabilization of the gabions are needed at the time of sediment removal, and the number of times removal is needed.

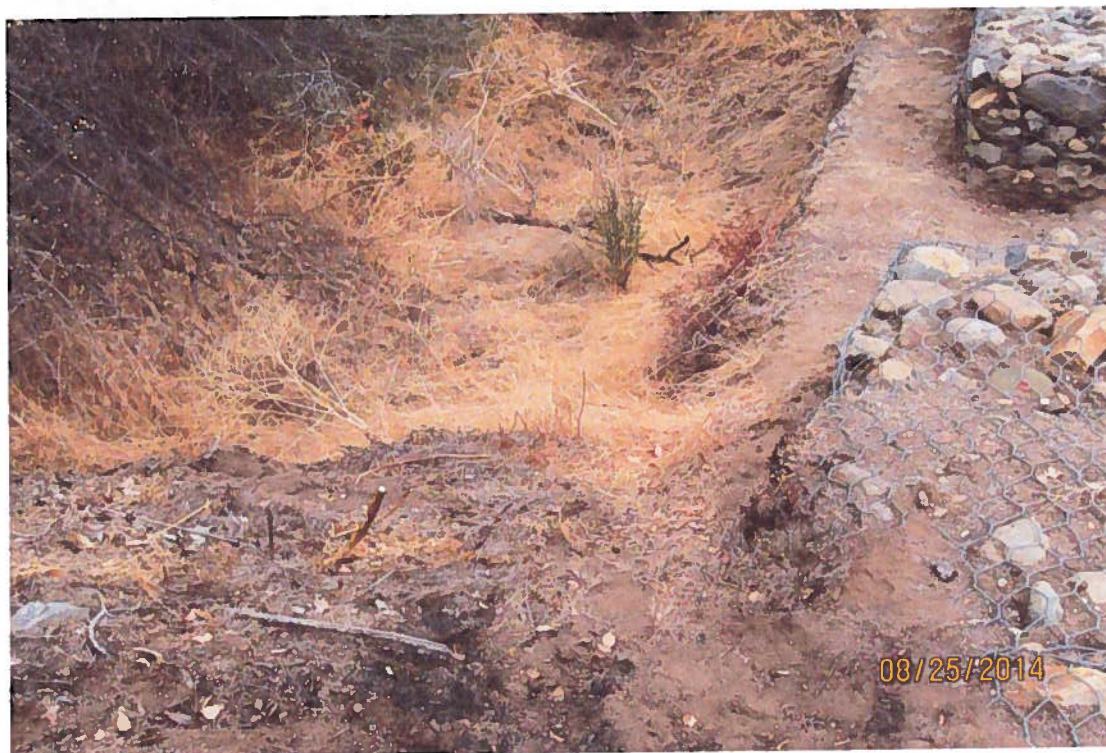
**Foresta Road Photo 2215 – Existing Debris Dam upstream side filled to near capacity.**
